Bathhouse Row Adaptive Use Program

The Fordyce Bathhouse: Technical Report

BATHHOUSE ROW ADAPTIVE USE PROGRAM
THE FORDYCE BATHHOUSE: TECHNICAL REPORT 5

HOT SPRINGS NATIONAL PARK
Garland County, Arkansas

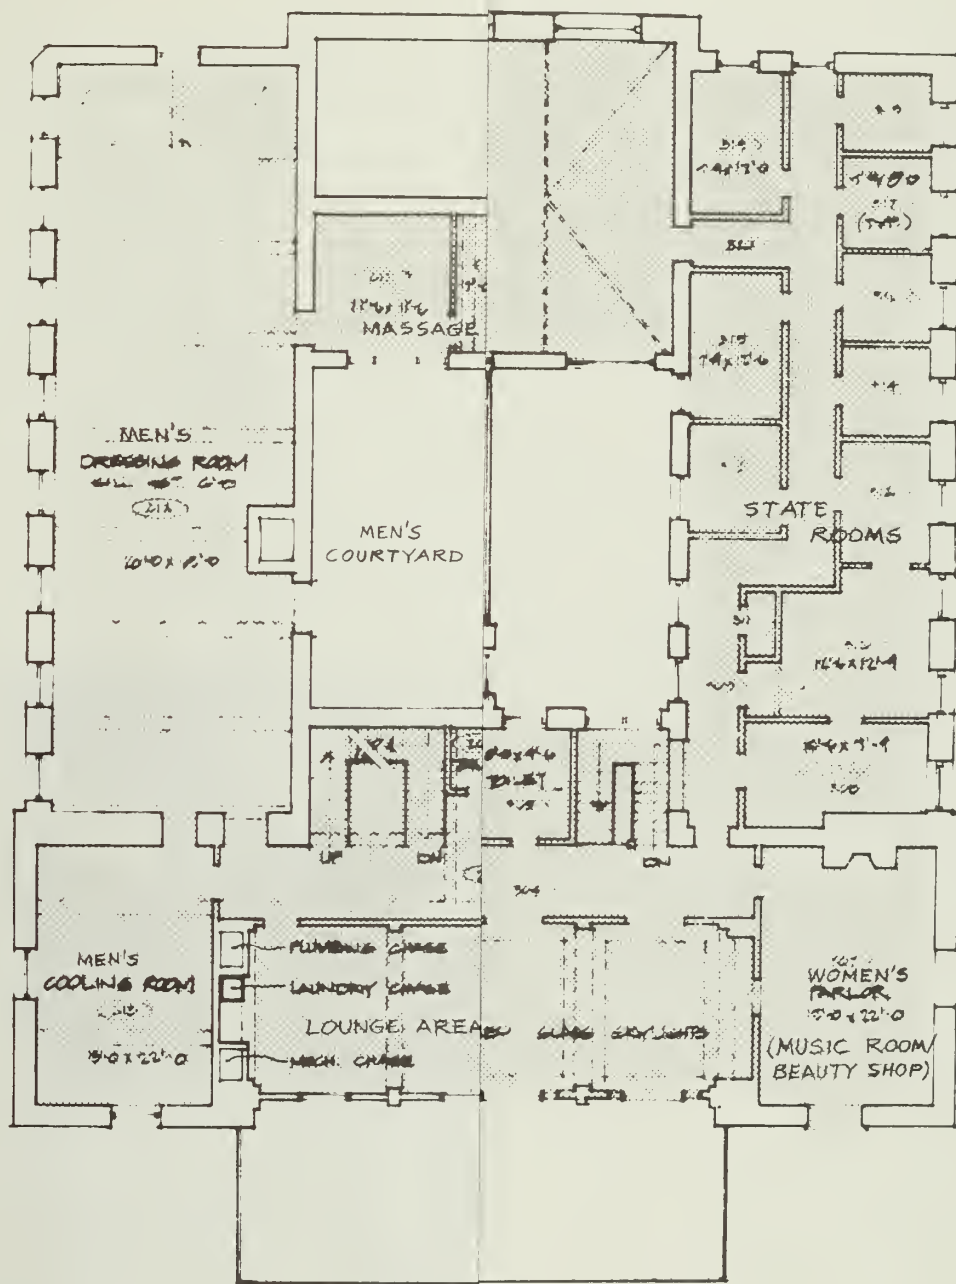
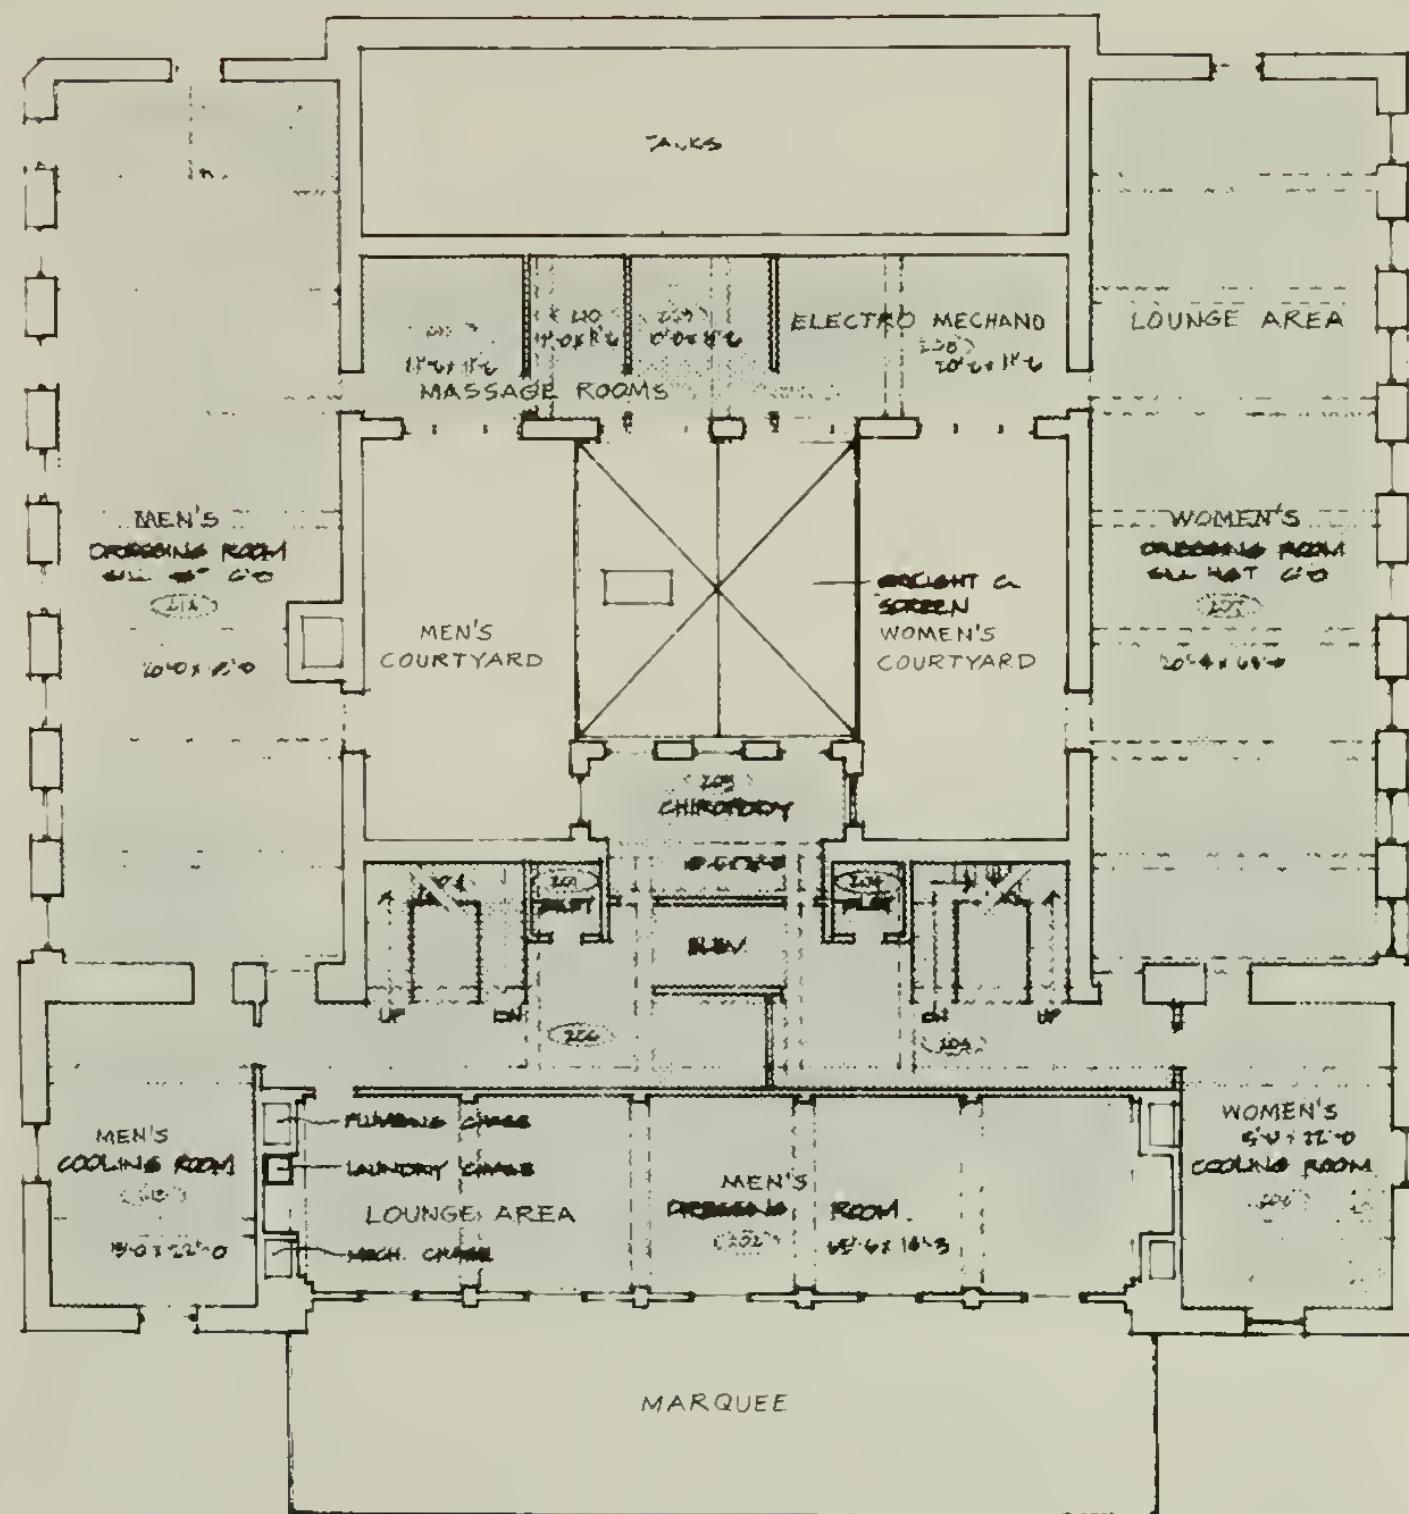
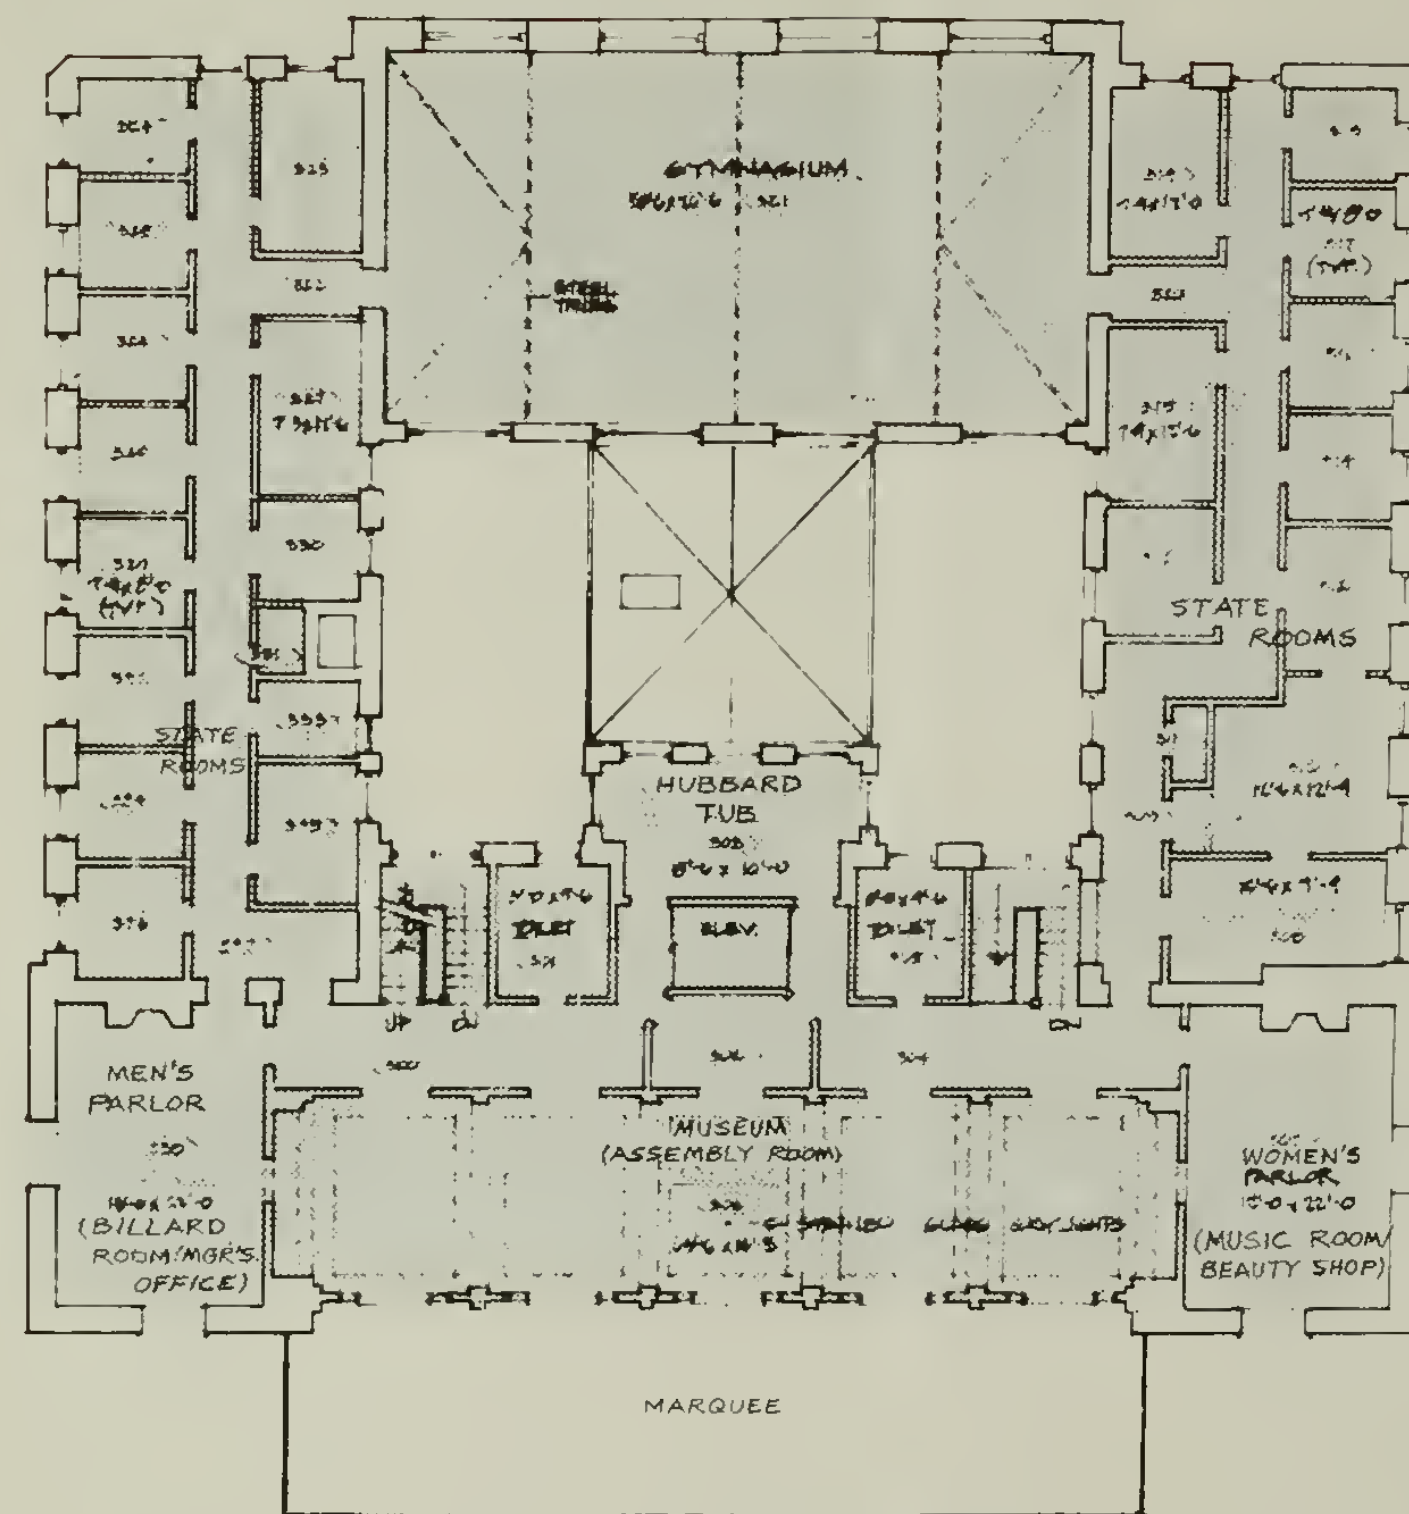
Figure 9

[Note: The capital letter symbols are cross references to the bathhouse floor plans, figures 5 and 8.]

<u>1973 Historic Structures Report</u>	<u>Investigative Study of Five Bathhouses</u>
Basement:	A	Large crack in ceiling.	This is not a severe crack. It is so small that it could not have changed much since 1973. It is a stress-relief crack. There are no diagonal cracks in the walls to indicate that settlement has occurred.
First Floor:	A	Buckling of tile corresponding to crack in ceiling of basement.	Stress-relief crack. There is no evidence that any recent attempt has been made to repair the floor tile. This floor tile could be repaired to a stable condition if a control joint were included in the tile over the stress-relief crack.
	B	Moisture damage, plaster fallen.	Repaired and stable. Some of the newly restored plaster in men's bath, 110, and on the wall of the main bath hall, 114, has fallen.
Second Floor:	A	Cracks - walls & floor.	Stress-relief cracks on the walls and floor are stable.

B	Cracks - walls & floor.	Stress-relief cracks on the walls and floor are stable.
	C	Cracks.	Stress-relief cracks on the floor are stable.
	D	Cracks.	Stress-relief cracks on the floor are stable.
	E	Plaster fallen.	Repaired and stable.
	F	Cracks in brick wall and through window sill. Quarry tile to be replaced.	Structural movement has occurred. Don't think much change has occurred since 1973.

G	Fine Cracks in brick walls.	The crack patterns indicate a settlement of the structural support in the corner. This is probably the result of a foundation settlement or masonry wall consolidation in this area. There is no sign of structural distress in the walls or concrete floors below. The movement of these elements has probably been absorbed in the more plastic interior brick and mortar joints. The exterior brick and mortar is very hard and crack with small movements.
	H	Large crack indicating movement of wall.	Same as G .
	I	Crack in floor.	Related to G and H . Appears to be stable.
	J	Settlement cracks in walls & floor.	Stress-relief cracks on the floor. Walls repaired and stable.
	K	Settlement cracks in wall & floor.	Stress-relief cracks on the floor. Wall repaired and stable.
Third Floor:	A	Settlement cracks in floor corners.	These are primarily stress-relief cracks, although there may have been some settlement in this area. Stable.

B	Plaster falling from ceiling and walls.	Not repaired. Probably caused by roof leaks, since repaired.
	C	Settlement cracks at floor corners.	Stress-relief cracks, stable.

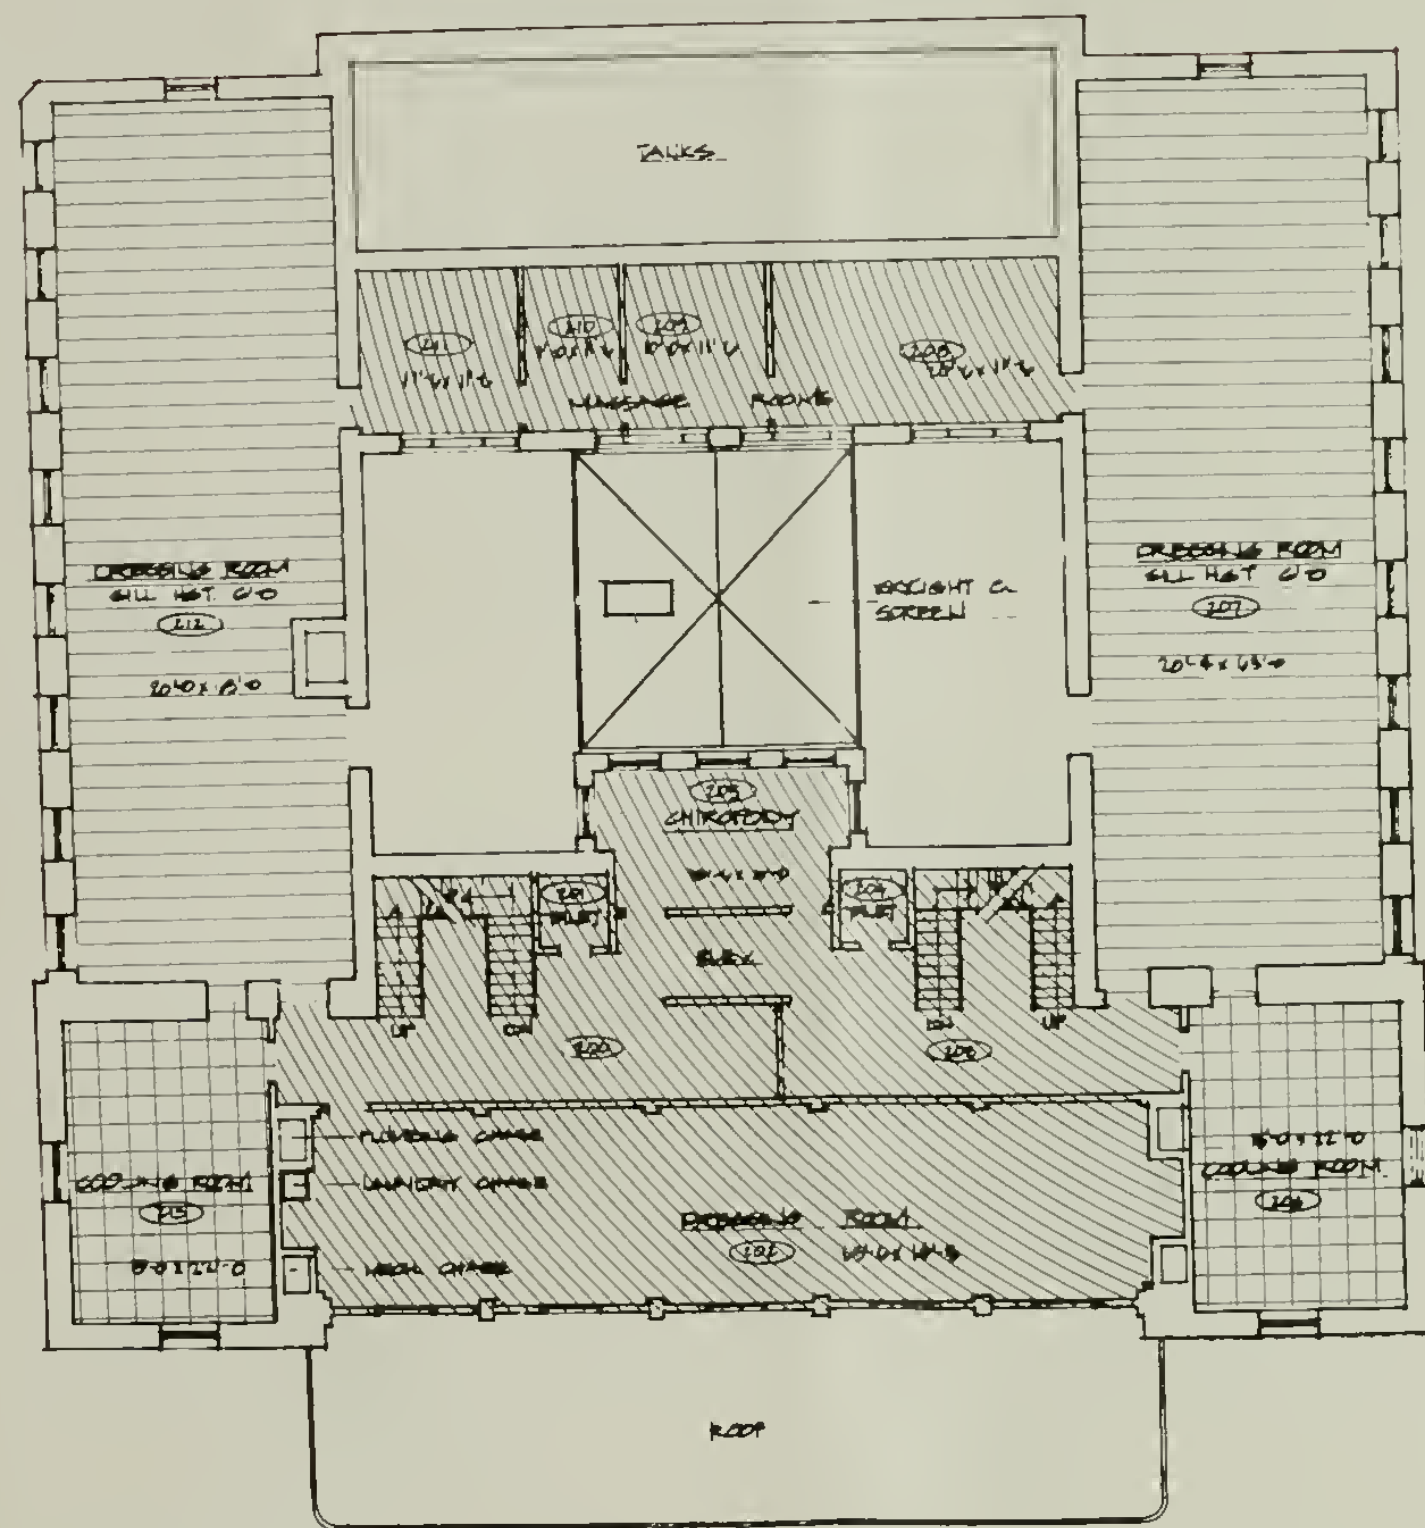
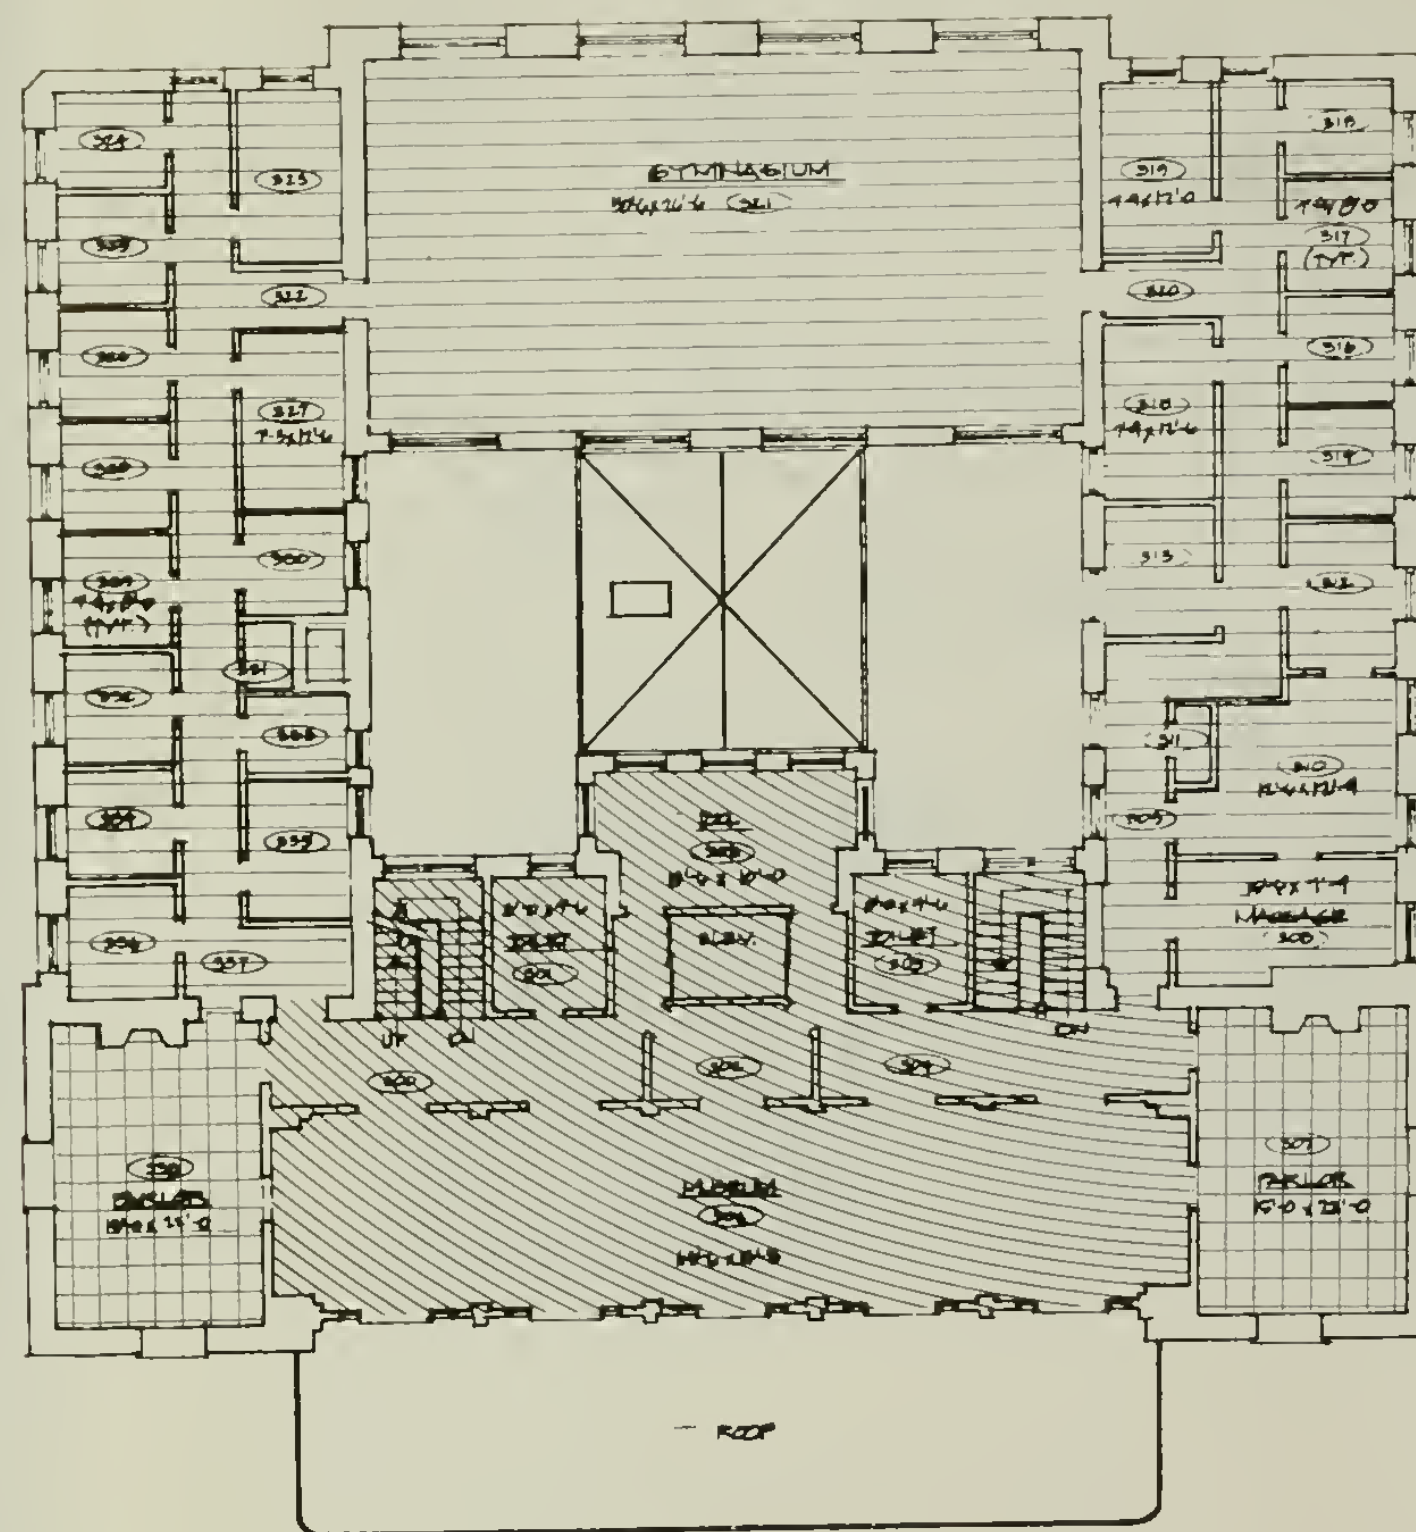
Figure 35

The structural capacities recommended in the Pitts report for the Fordyce Bathhouse are depicted on figures 34 and 35. Engineering drawings showing structural systems and details at 1/4 scale are available at the park. The Appendix contains excerpts from the Pitts report which describe existing conditions at the Fordyce Bathhouse in three parts:
